**Flood Control Project Maintenance
Levee Inspections**

Fall 2014 Levee Maintenance Deficiency Summary Report

Sacramento River Basin

Waterway	Bank	Unit Miles	Inspection Start/End	Inspector
Unit No. 01 Right Bank Cache Creek	Right	0.59	11/12/2014 11/12/2014	Clay Thomas

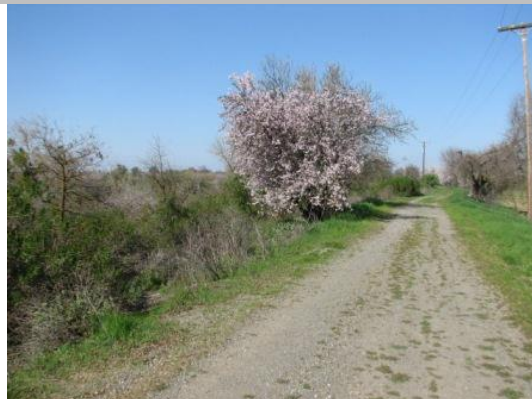
Photo 1 of 3 : FA_2014_NA0021_351_17_20141014_00015.jpg

LM Start	0.01	Rating **	U	Issue No.	17
LM End	0.26	Issue Type +	Ma	Location *	WS
Category	Earthen Levee			GPS Latitude/Longitude	
				Start	End
Item	Vegetation			38.722220 °	38.725887 °
				-121.806966 °	-121.806550 °
DWR ID	DWR_NA0021_01_s_2012_17				
Action/Comments					
Remove the wild growth other than native grasses from the levee slopes.

Vegetation and brush is taller than 12 inches. No visibility of the waterside berm. Spring 2013

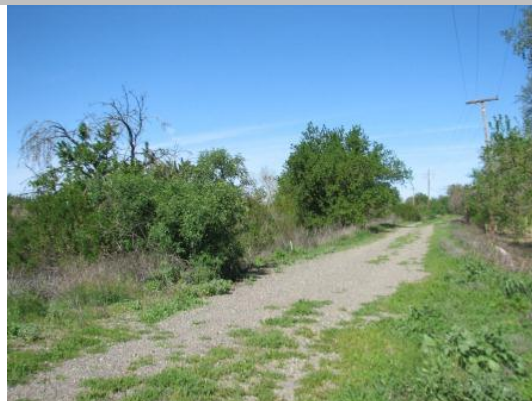
Photo 2 of 3 : FA_2014_NA0021_351_17_20141014_00016.jpg

Tall grasses and brush on the waterside berm area. Spring 2014

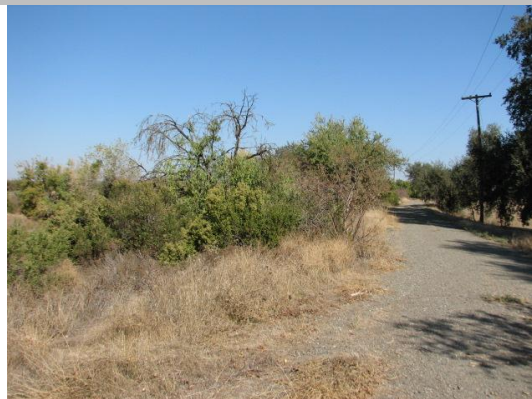
Photo 3 of 3 : FA_2014_NA0021_351_17_20141014_00017.jpg

The vegetation on the waterside is over grown. Fall 2013

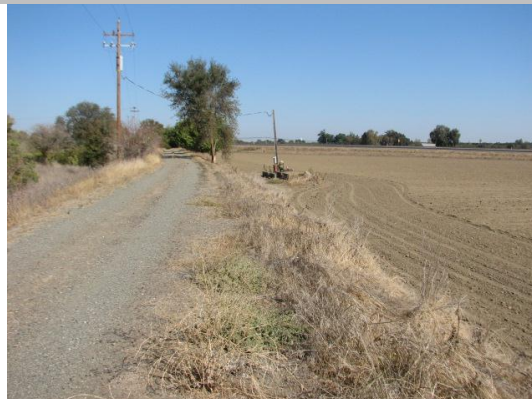
Photo 1 of 3 : FA_2014_NA0021_351_1_20141014_00001.jpg

LM Start	0.08	Rating **	M	Issue No.	1
LM End	0.26	Issue Type +	Ma	Location *	LS
Category	Earthen Levee			GPS Latitude/Longitude	
				Start	End
Item	Vegetation			38.723381 °	38.725835 °
				-121.806786 °	-121.806526 °
DWR ID	DWR_NA0021_01_s_ 2012_1				
Action/Comments					
Remove the wild growth other than native grasses from the levee slopes.					
Inspector Comments: This area now has been declared a habitat restoration area by the Cache Creek Conservancy.

The vegetation partially blocking visibility. Fall 2013

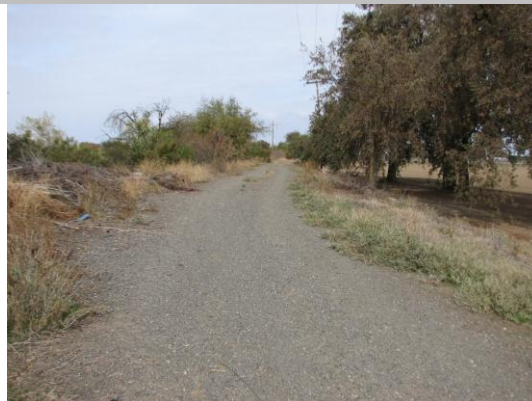
Photo 2 of 3 : FA_2014_NA0021_351_1_20141114_00085.jpg

Vegetation on levee slopes and crown. Fall 2014.

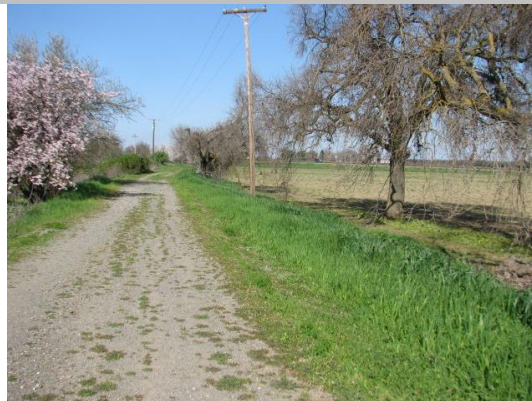
Photo 3 of 3 : FA_2014_NA0021_351_1_20141014_00002.jpg

Vegetation needs to be mowed taller than 12". Spring 2013

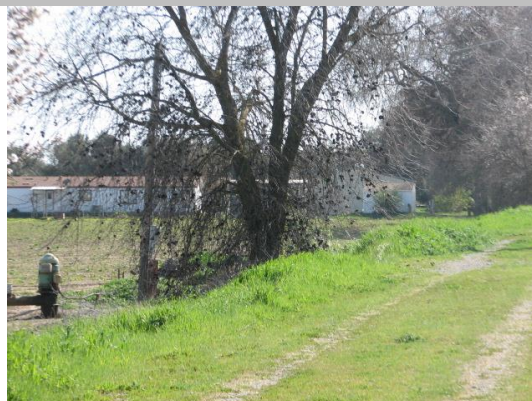
Photo 1 of 1 : FA_2014_NA0021_351_6_20141014_00008.jpg

Tree needs to be trimmed up 5'. Spring 2013

LM Start	0.13	Rating **	M	Issue No.	6
LM End	0.13	Issue Type +	Ma	Location *	LS
Category	Earthen Levee			GPS Latitude/Longitude	
				Start	End
Item	Trim / Thin Trees			38.723903 °	38.723903 °
				-121.806613 °	-121.806613 °
DWR ID	DWR_NA0021_01_s_2012_6				
Action/Comments					
Trim trees to at least five feet above ground level.

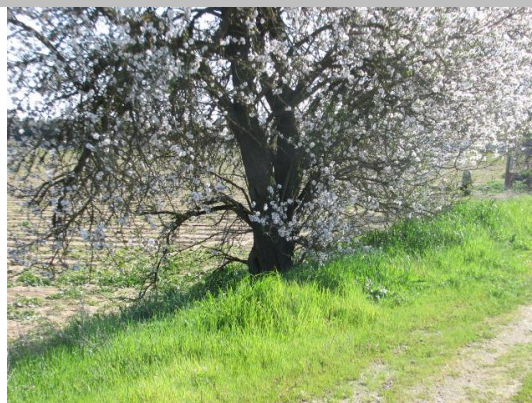
Photo 1 of 1 : FA_2014_NA0021_351_7_20141014_00009.jpg

Tree needs to be trimmed to 5'. Spring 2013

LM Start	0.15	Rating **	M	Issue No.	7
LM End	0.15	Issue Type +	Ma	Location *	LS
Category	Earthen Levee			GPS Latitude/Longitude	
				Start	End
Item	Trim / Thin Trees			38.724165 °	38.724165 °
				-121.806552 °	-121.806552 °
DWR ID	DWR_NA0021_01_s_2012_7				
Action/Comments					
Trim trees to at least five feet above ground level.

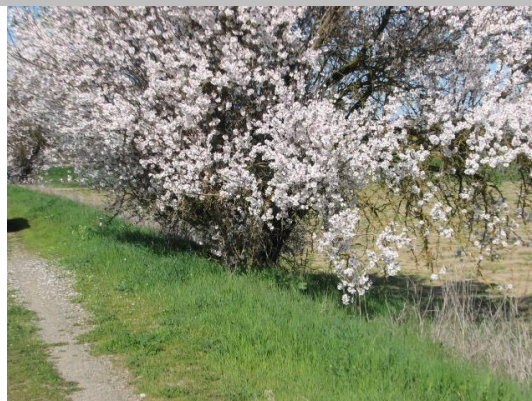
Photo 1 of 1 : FA_2014_NA0021_351_8_20141014_00010.jpg

Trees need to be trimmed to 5'. Spring 2013

LM Start	0.17	Rating **	M	Issue No.	8
LM End	0.17	Issue Type +	Ma	Location *	LS
Category	Earthen Levee			GPS Latitude/Longitude	
				Start	End
Item	Trim / Thin Trees			38.724445 °	38.724445 °
				-121.806505 °	-121.806505 °
DWR ID	DWR_NA0021_01_s_2012_8				
Action/Comments					
Trim trees to at least five feet above ground level.

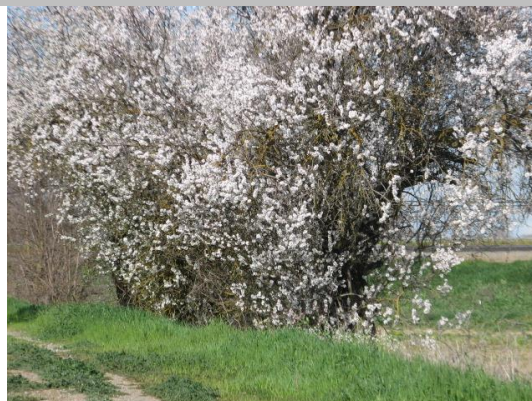
Photo 1 of 1 : FA_2014_NA0021_351_9_20141014_00011.jpg

Trees need to be trimmed to 5'. Spring 2013

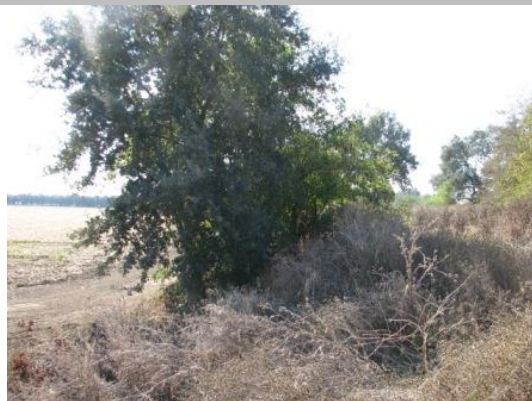
Photo 1 of 1 : FA_2014_NA0021_351_10_20141014_00012.jpg

The tree needs to be trimmed up. Photo taken fall of 2011.
